2nd BLACK BELT Project in Sagunto: Breakage Reduction in Assembly Area

The target of this black belt project is the reduction from 1.3% to 1% of assembly area breakage losses

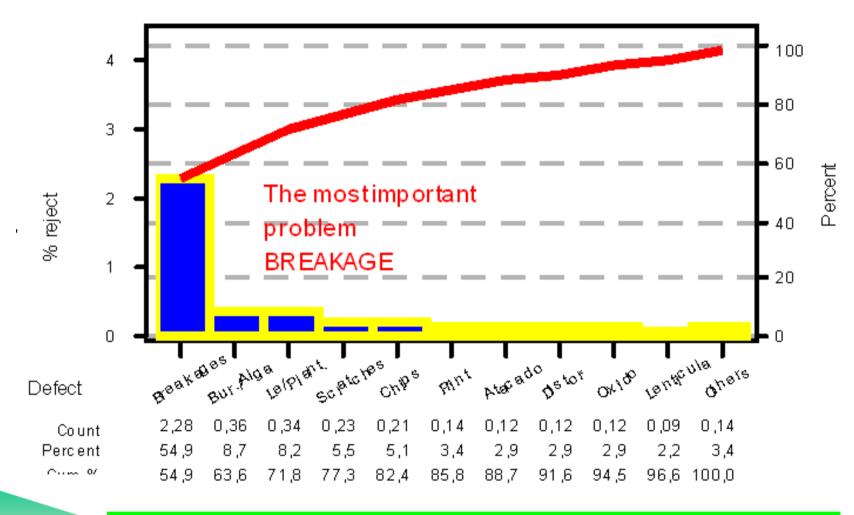
Percentage of defects in Laminated Line

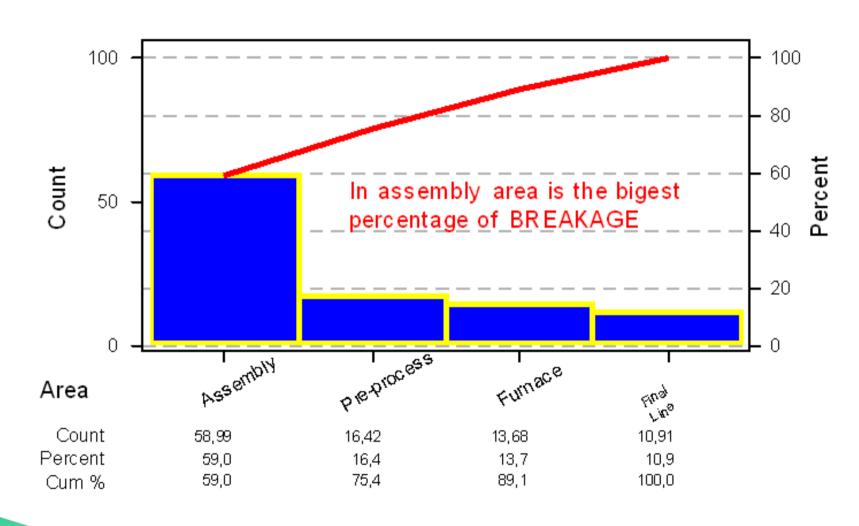
Percentage of BREAKAGE per phase in Laminated Line

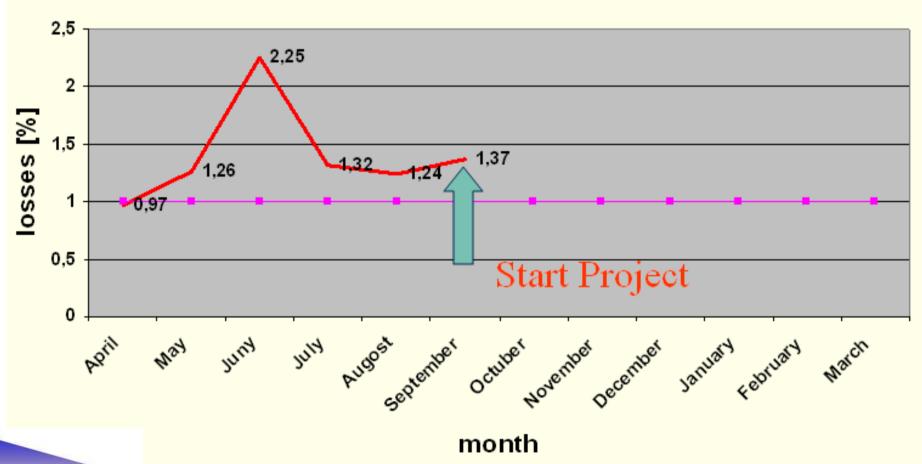
Primary metric: % breakage in Assembly area

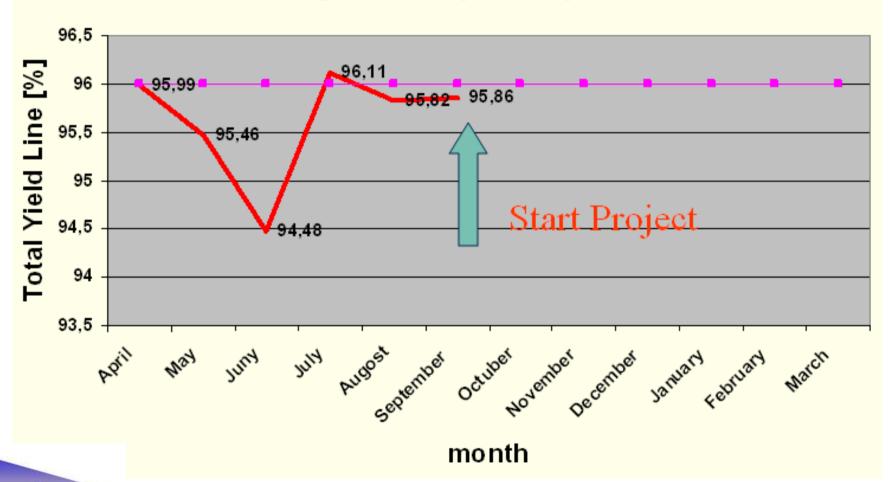
Trend chart of % Total Yield in Sagunto Laminating Line April-September

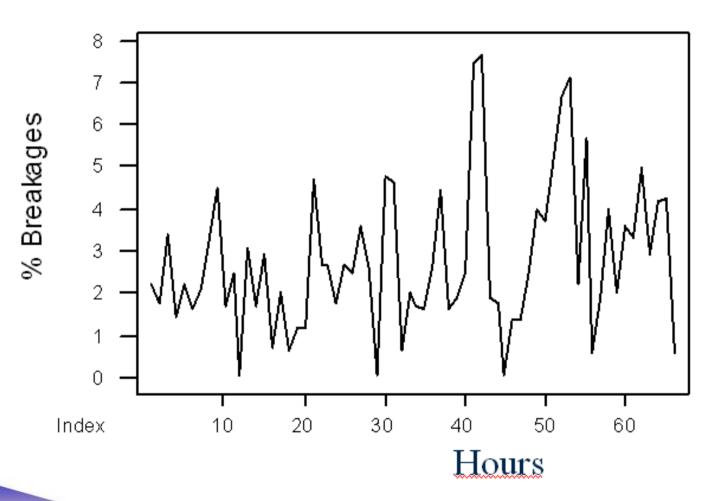
Paramethers (inputs assembly) Model

Data collect by operators Frecuency (1 Hour)

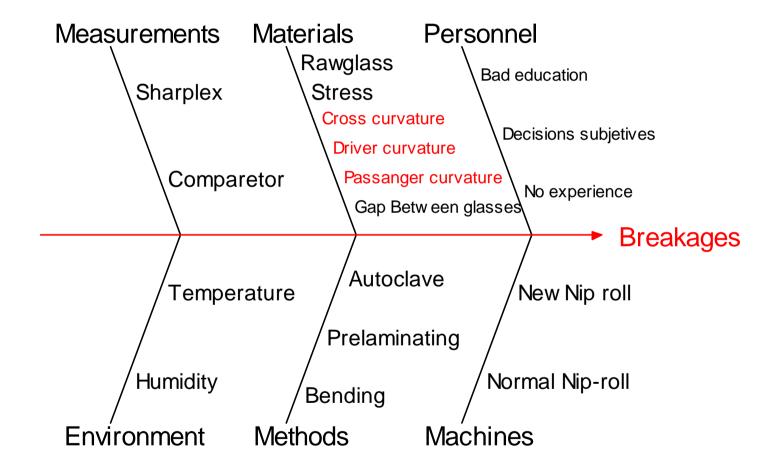
Cause-and-Effect Diagram

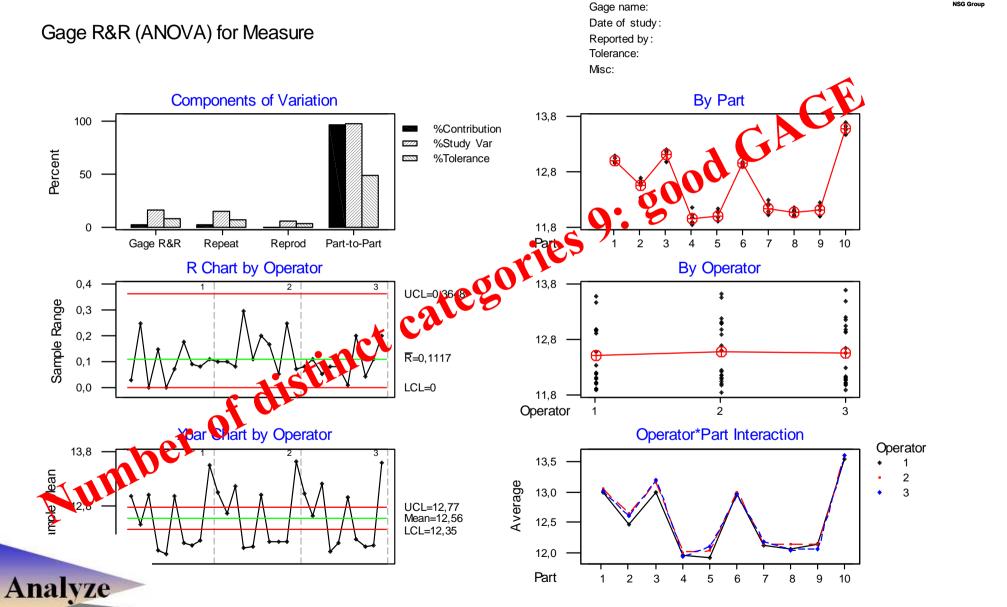
R&R Gage "Comparator" for cross curvature

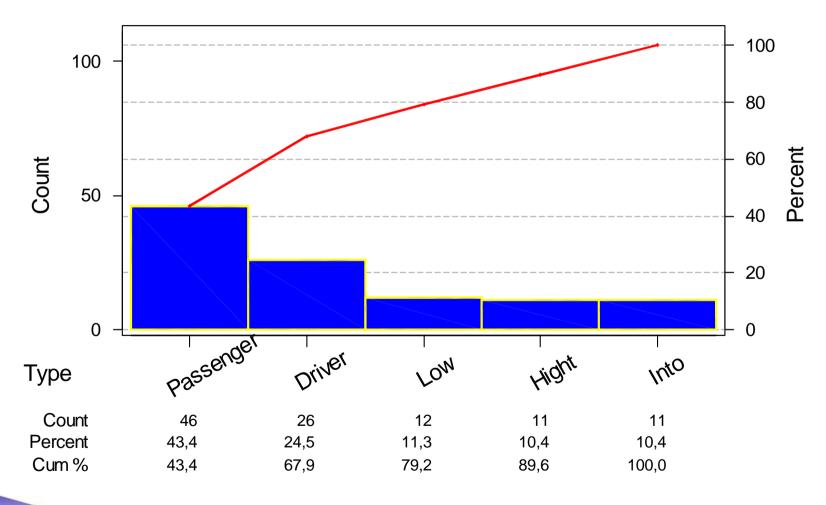
- 47 start at PASSENGER side; 44 %.
- − 26 start at DRIVER side; 24.2 %.
- 11 HIGHT energy 10.2%;
- 12 LOW energy 11.2%;
- -11 start at INTO the WS;10.2%.

Pareto Chart for Type of Breakages

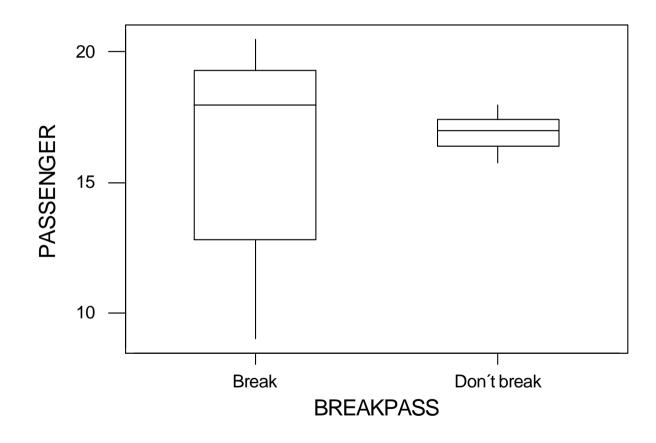
Analysis of the Curvature for PASSENGER and DRIVER

- The passenger and driver curvature is the most important cause of the breakage at assembly area (NIP ROLL).
- The curvature is due to variability in the glass and is an output (Y) of the furnace.
- The passenger and driver curvature aren't specifications of the customer.
- Only one curve is measured at the NIP ROLL. However, the WS has three curves (centre, driver, passenger) which affect breakage.

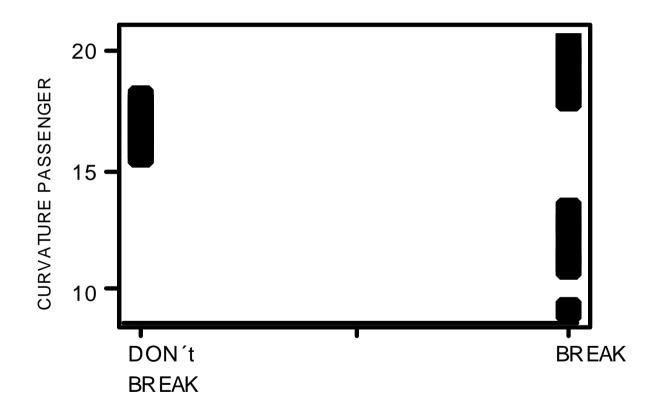
Scatter plot, curvature passenger-Break - Not Break

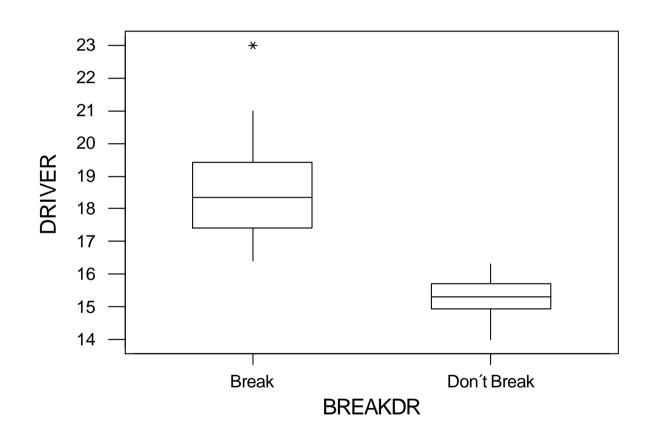
Analysis of the Curvature for PASSENGER and DRIVER

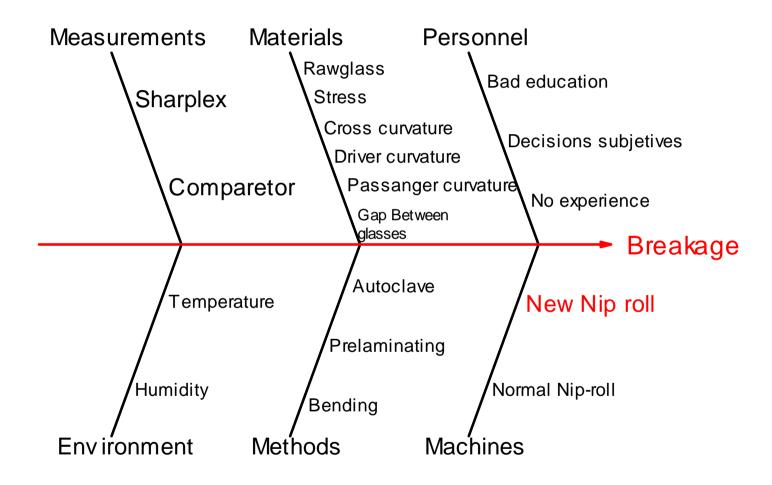
Cause-and-Effect Diagram

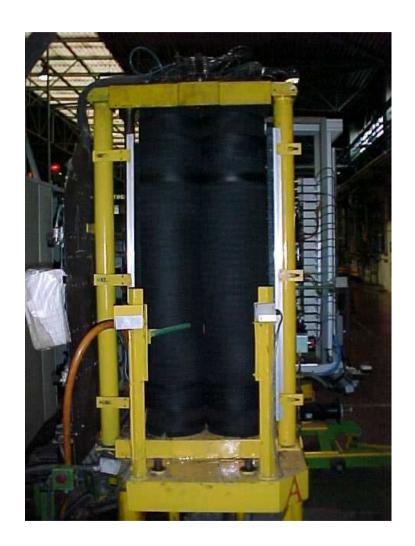
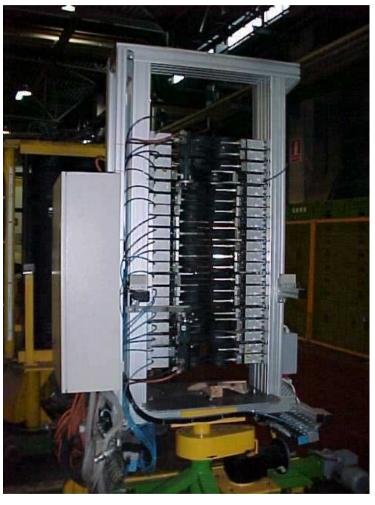
Nip Rolls

- ➤ In Sagunto we have developed a new NIP roll. (We have only one)
- Next action: to do a trial with this new nip roll at the 2nd place (after the second IR oven), and compare with other batches. (Model XX)

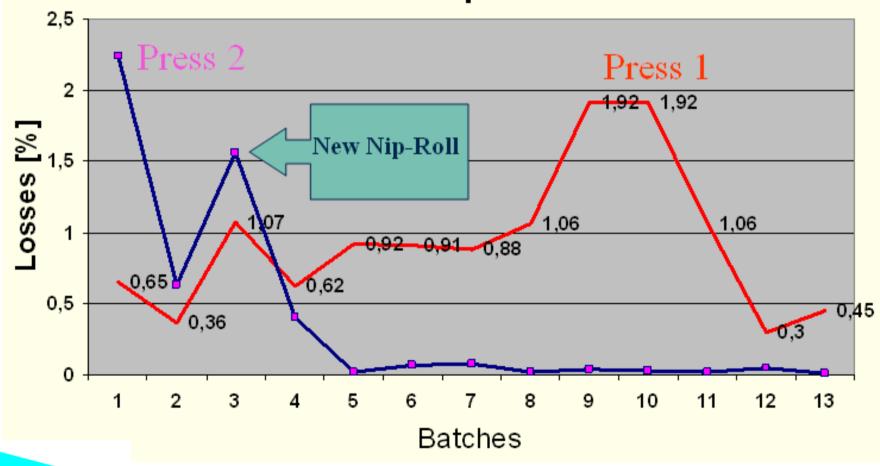
Trend chart of % breakage in each nip roll in the model XX per batches
